# Taper-Lok

## FIELD REPAIR PROCEDURES FOR (MISALIGNMENT/ SWIVEL/ WELDNECK)

**Used for:**  
**ITF / ConocoPhillips China**  
**Bohai Bay Project**

**Document Number: TLFRP-05-4667**

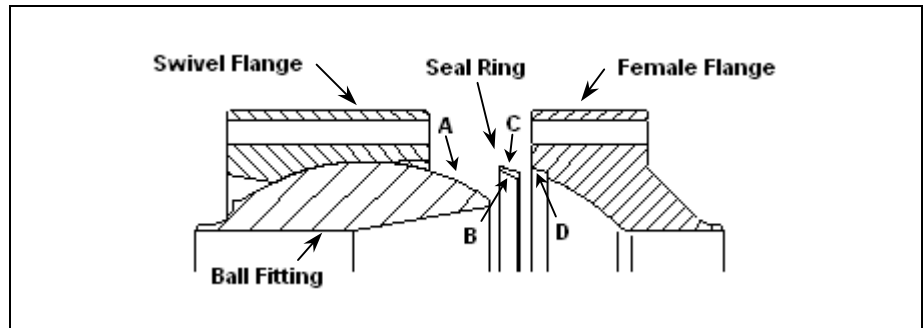
**FIGURE 1-1**

This procedure discusses about the Repair Of Minor Damage To Seal Surfaces. First, contact Taper-Lok for evaluation of any damage to the sealing surfaces. The sealing surfaces for Misalignment Flange are shown in Figure 1-1, for Swivel Flange in 1-2, and Weld Neck Flange in 1-3 below respectively. NOTE: The following procedure is for informational purposes only. Please do not perform any actions of repair till Taper-Lok is contacted.

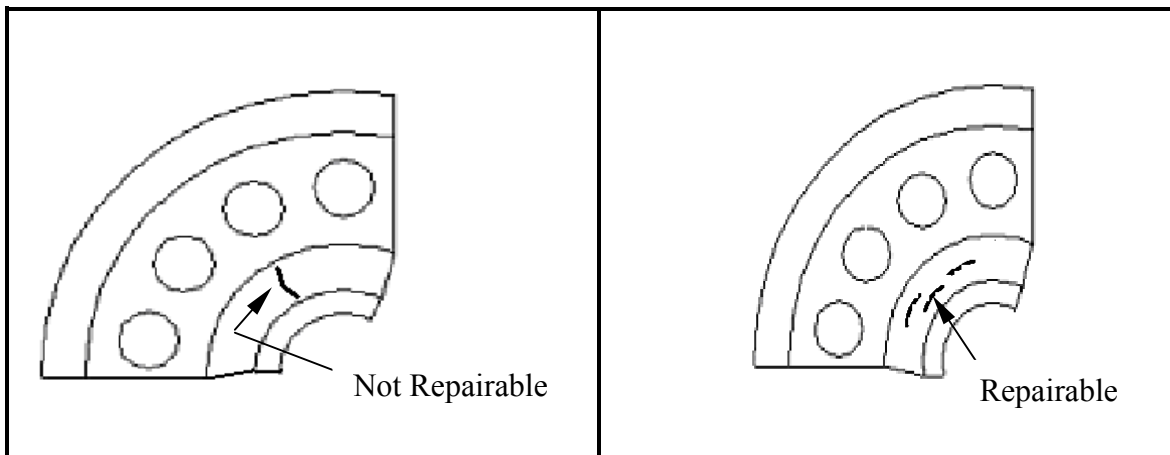
**FIGURE 1-4**

- Figure 1-4 shows a Male seal surface that is not repairable and one that is repairable. **Contact Taper-Lok for both situations before taking any actions.** The following steps indicate how to repair the repairable portion of damage. Shallow scratches (shown in the repairable section of Figure 1-4 below) and any surface blemishes can be removed by lightly buffing first with (240) grit followed by (320) grit emery cloth.

This method is only for repair of minor damages to seal surfaces without the use of welding or shop/works machining. Any displaced material that is not removed will cause the seal ring to be damaged during installation. Consequently, leakage will certainly result.

Damage severe enough to cause metal displacement should be evaluated to determine if this repair method is suitable. Taper-Lok will review and advise of appropriate actions to be taken for repairable or not repairable conditions.

Severe damage will require machining of the entire seal surface. Although Taper-Lok seal rings can be used 10 or more times before replacing them, severely damaged seal rings should be replaced to prevent damage to the female pocket or male seal surface during installation.
