High Pressure Heat Exchanger Diaphragm Removal/Retrofit Using Double Tapered Pressure Seal

This conference paper describes the successful removal of a tube side cover plate diaphragm (gasket) from a high pressure heat exchanger. The diaphragm was replaced with a double-tapered, metal pressure seal. This seal has been utilized in multiple piping and off-shore applications throughout the world for several years; however, this was the first known application on a heat exchanger of this magnitude within a refinery. Using creative thinking and taking the initiative, a reoccurring reliability issue (diaphragm weld cracking and subsequent process leakage to atmosphere) was resolved, all during a turnaround window (an opportunity!). Modification of the cover plate to accept the double-tapered, metal pressure seal eliminated the need to re-install the metal diaphragm gasket, thereby saving 75% of the reassembly cost of the exchanger. Utilized in conjunction with mechanical multi-jack bolt tensioners, this innovative retrofit has eliminated a reoccurring costly problem (in both maintenance cost and loss of opportunity). This additional reliability coupled with the significant future cost sa

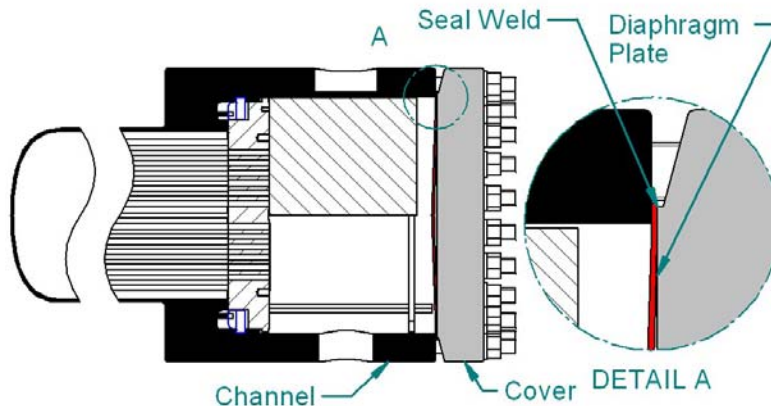
It is not uncommon for diaphragm plates in high pressure heat exchangers to develop cracks in their seal welds. The diaphragm, which is generally a thin plate of alloy steel serves as the gasket and corrosion resistant liner for the channel cover (Figure 1). This arrangement is common for heat exchangers in hydrogen services at

Figure 1 – Schematic of exchanger design with diaphragm

Until recently, our repair process had been the same. It entailed removing the diaphragm, machining the channel face, welding and re-machining a nickel "butter-coat" layer on to the channel face, and finally welding on a new diaphragm under controlled heat. This repair would suffice for a time, until some process upset or other anomaly would create another cracking "event."

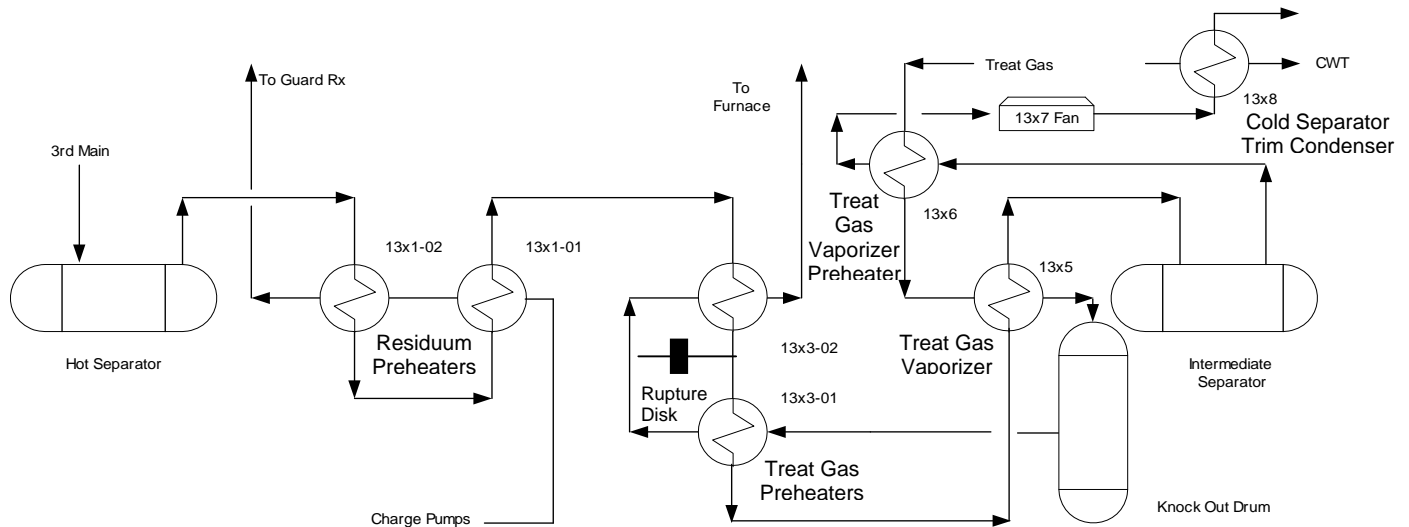
Faced with repeated failures of the diaphragm welds in our hydrotreater exchangers (fourteen exchangers, seven in two separate trains – Figure 2) and the economic impact of these exchangers to the refinery, developing a solution to this phenomenon became a priority.

Figure 2– Process schematic of GOHT single train high pressure heat exchanger section

During the refinery start up following hurricane Rita (from which we were gratefully spared) in September, 2005 a leak occurred in our GOHT Cold Separator Trim Condenser (Figure 2, previous). The leak was from a small crack in the diaphragm weld just in front of the tube side cover plate.

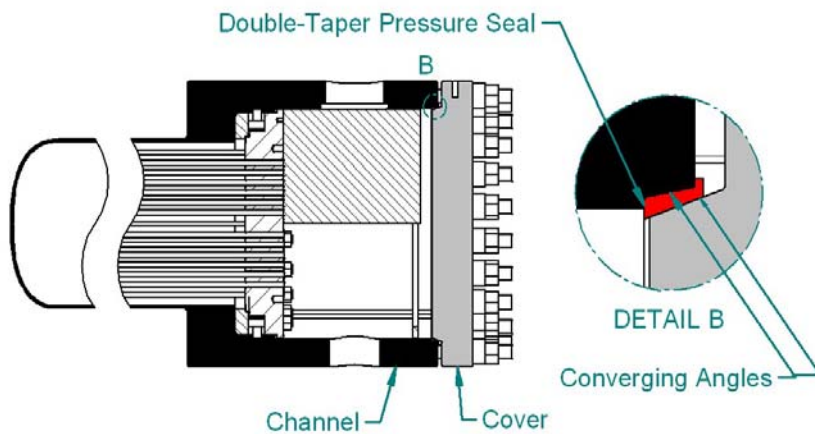
Figure 3 – Schematic of exchanger design with double taper pressure seal⁵

The Reliability and Maintenance groups designed or investigated a handful of possible solutions; however none of them received total buy in. Following several months of study, an innovative, alternate solution was identified. The solution involved eliminating the diaphragm plate entirely and replacing it with a double-tapered, self-energizing metal pressure seal (Figure 3).

In the pre-bolted condition, the seal ring lip stands off of the face of the channel. The converging seal surfaces are brought together like a wedge during bolt up. This wedging motion forces the seal ring onto the male nose and into the female pocket forcing a compressive hoop stress. Minimal bolt load is required to achieve the required contact stress on the seal surfaces.

The converging angles of the seal ring create a wedge or “door stop” effect. As the equipment internal pressures increases the seal seats tighter into this sealing wedge.

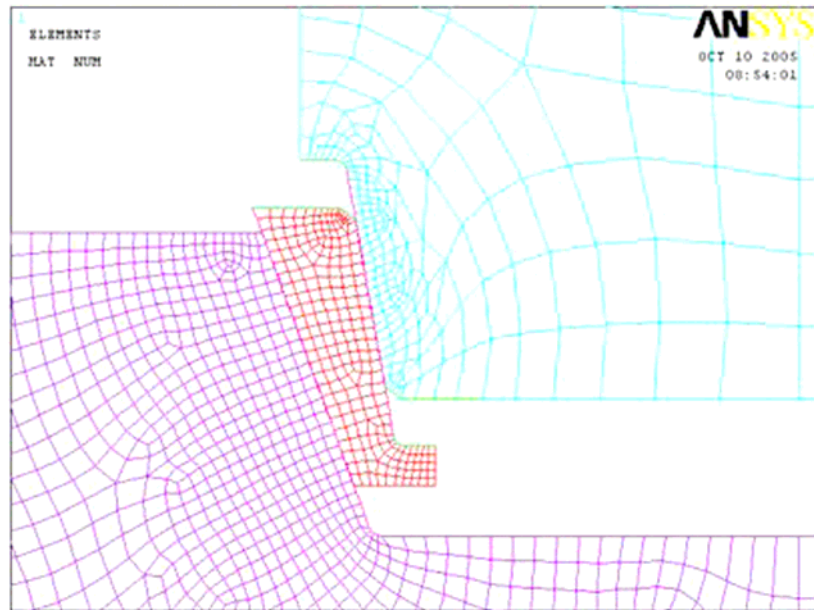
A finite element analysis (FEA) was conducted by an independent third-party engineering firm.⁸ Analysis consisted of both 2D and 3D nonlinear models with contact elements. Both models showed a wide contact area with pressures at the sealing surfaces to be in excess of 20ksi (Figure 4). The analysis verified that the seal would be kept

Figure 4 – FEA of pressure seal illustration of mesh used in the analysis

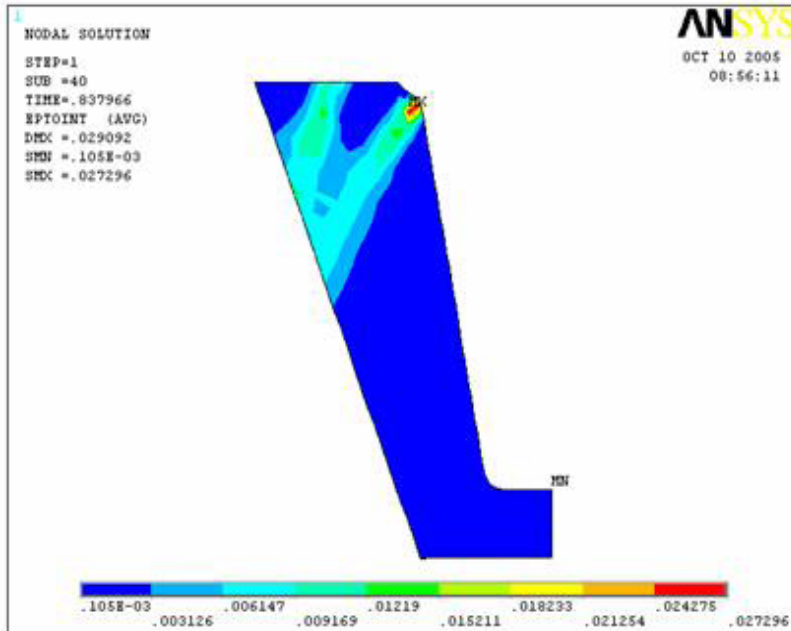
in an elastic state and that the stresses in the components

would be below code allowable limits (Figure 5).

Figure 5 – FEA of pressure seal illustration of strain on seal

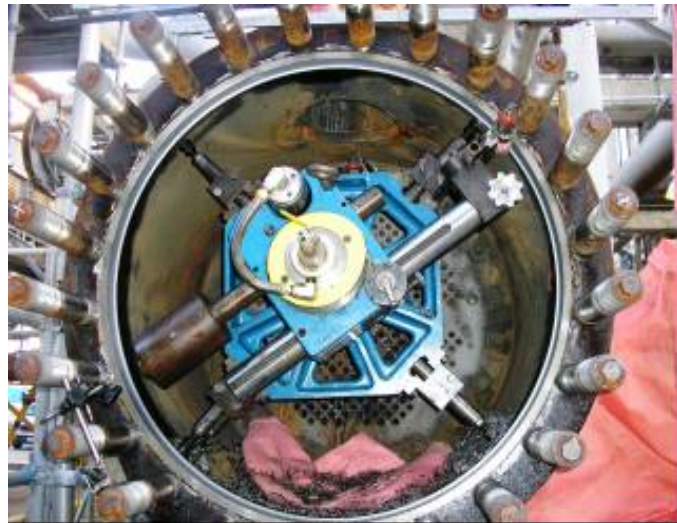
Figure 6 - Machining pressure seal female pocket with ID mounted tool

Field Machine Female Pocket Into Exchanger Channel (Figure 6)

The double angled pressure seal geometry requires two sealing surfaces. One, a female pocket, the other a male nose. The female pocket was machine cut into the exchanger channel while the new, fabricated channel cover plate featured the male nose. During assembly, an additional benefit to the design was observed. This male nose on the channel cover plate configuration acted as a guide.

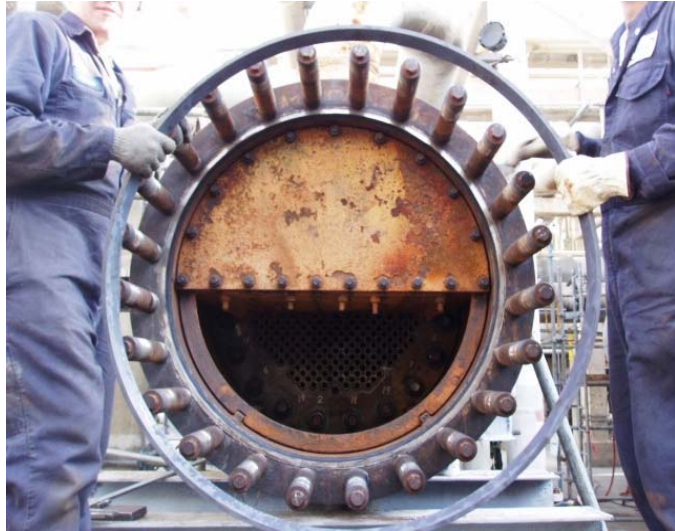
Insert Pressure Seal Ring Into Pocket (Figure 7)

Since the geometry of the female seal pocket is angled, the seal ring was installed into the female pocket and held in place by friction, providing a hands free, safe installation of the channel cover plate.

Figure 7 – Inserting pressure seal into female pocket

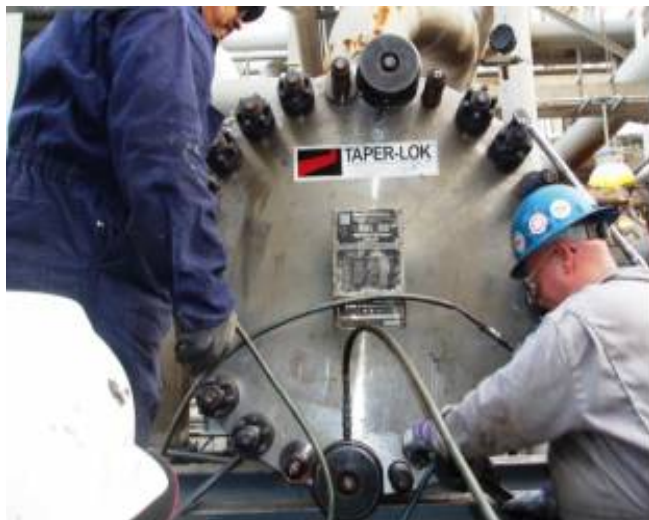
Pre-tension studs (Figure 8)

To ensure that the channel cover plate was assembled square and free from misalignment and to reduce bolt interactions, hydraulic tensioning equipment was utilized. Four (4) tensioners were used at ninety (90) degrees and the tensioners were kept under load while all nuts were installed and hand tightened.

Figure 8 - Hydraulic tensioning and installation of mechanical tensioners

mechanical multi-jack bolt tensioners were utilized. This also proved quite fruitful as torque wrenches were then used to apply the proper torque required to seat the double angled pressure seal. The traditional impact (and accompanying crane used to hold it in place) was rendered obsolete.

Hot torquing was not necessary after the installation, even after the unit had gone through a few cycles. This is attributed to the spring affect the seal and component geometry create during and after seal seating. This spring effect refrains the bolts from relaxing.
