FIELD REPAIR PROCEDURES FOR (MISALIGNMENT/ SWIVEL/ WELDNECK)

Used for:
ITF / ConocoPhillips China
Bohai Bay Project

Document Number: TLFRP-05-4667

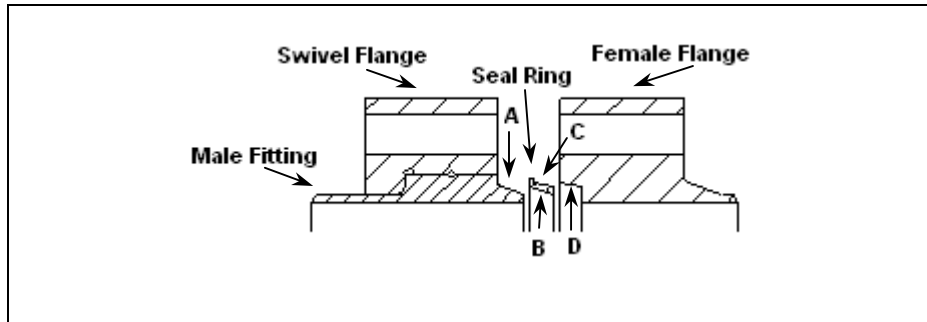
FIGURE 1-2

The following is the procedure for repairing minor damage to sealing surfaces and corners (shown in Figures 1-1, 1-2, & 1-3 above) of Male Seal Surface (A), Seal Ring ID Seal Surface (B), Seal Ring OD Seal Surface (C), and Female Seal Surface (D), where damage marks are (3/16") or less in length.

This procedure discusses about the Repair Of Minor Damage To Seal Surfaces. First, contact Taper-Lok for evaluation of any damage to the sealing surfaces. The sealing surfaces for Misalignment Flange are shown in Figure 1-1, for Swivel Flange in 1-2, and Weld Neck Flange in 1-3 below respectively. NOTE: The following procedure is for informational purposes only. Please do not perform any actions of repair till Taper-Lok is contacted.
